WARNING

Watch out for shallow water in the south side of NUMAZU Port

Shimizu Coast Guard Office

Created in
October 2023,

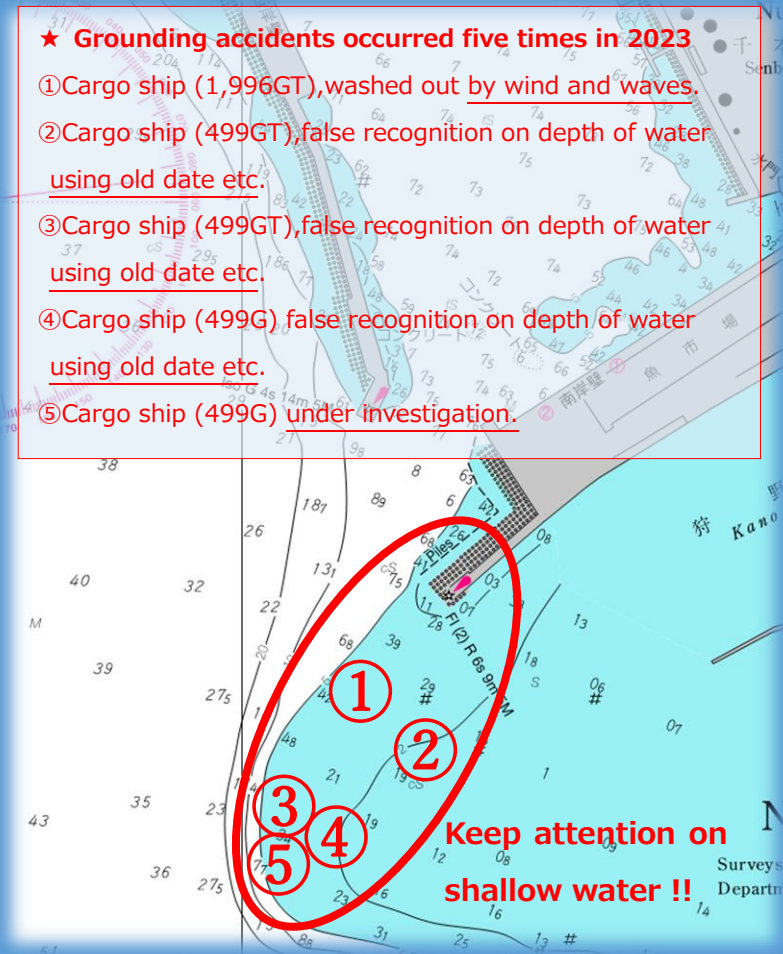
*Note that the chart on the diagram on the right is an older version, and the depth shown here does NOT reflect the actual one. It is only used to address the grounding incidents. Please use the latest for your navigation.

★ Grounding accidents occurred five times in 2023

- ① Cargo ship (1,996GT), washed out by wind and waves.
- ② Cargo ship (499GT), false recognition on depth of water using old date etc.
- ③ Cargo ship (499GT), false recognition on depth of water using old date etc.
- ④ Cargo ship (499GT) false recognition on depth of water using old date etc.
- ⑤ Cargo ship (499GT) under investigation.

- ☞ Prior check on course line including depth of water.
(Use latest charts (GPS date).)
- ☞ Correct understanding on your position.
(Special care on sea current and river flow.)
- ☞ Appropriate maneuver according to weather and sea-state
