# Examples of HNS Accidents Handled by the Japan Coast Guard

**JAPAN COAST GUARD  
NATIONAL STRIKE TEAM**

# Stranding Accident of the "Takasago 2", a LPG Tanker

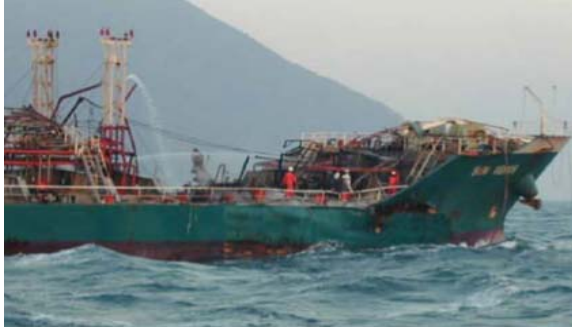
**The "SUN-VENUS", a ethanol tanker Explosion-and-burning-in-flames accident**

**December 24, 2003**

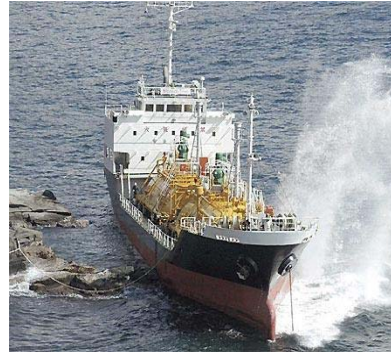
**The "Takasago 2", a LPG tanker Stranding accident**

**March 29, 2005**

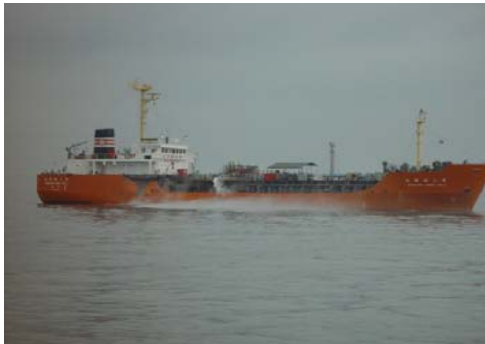
**The "No. 2 Shokakumaru", a liquefied gas tanker Collision**

**July 9, 2005**

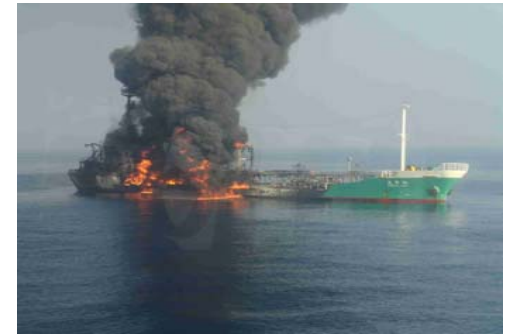
**The "Kyokuyoumaru", a benzene tanker Fire accident**

**July 15, 2005**

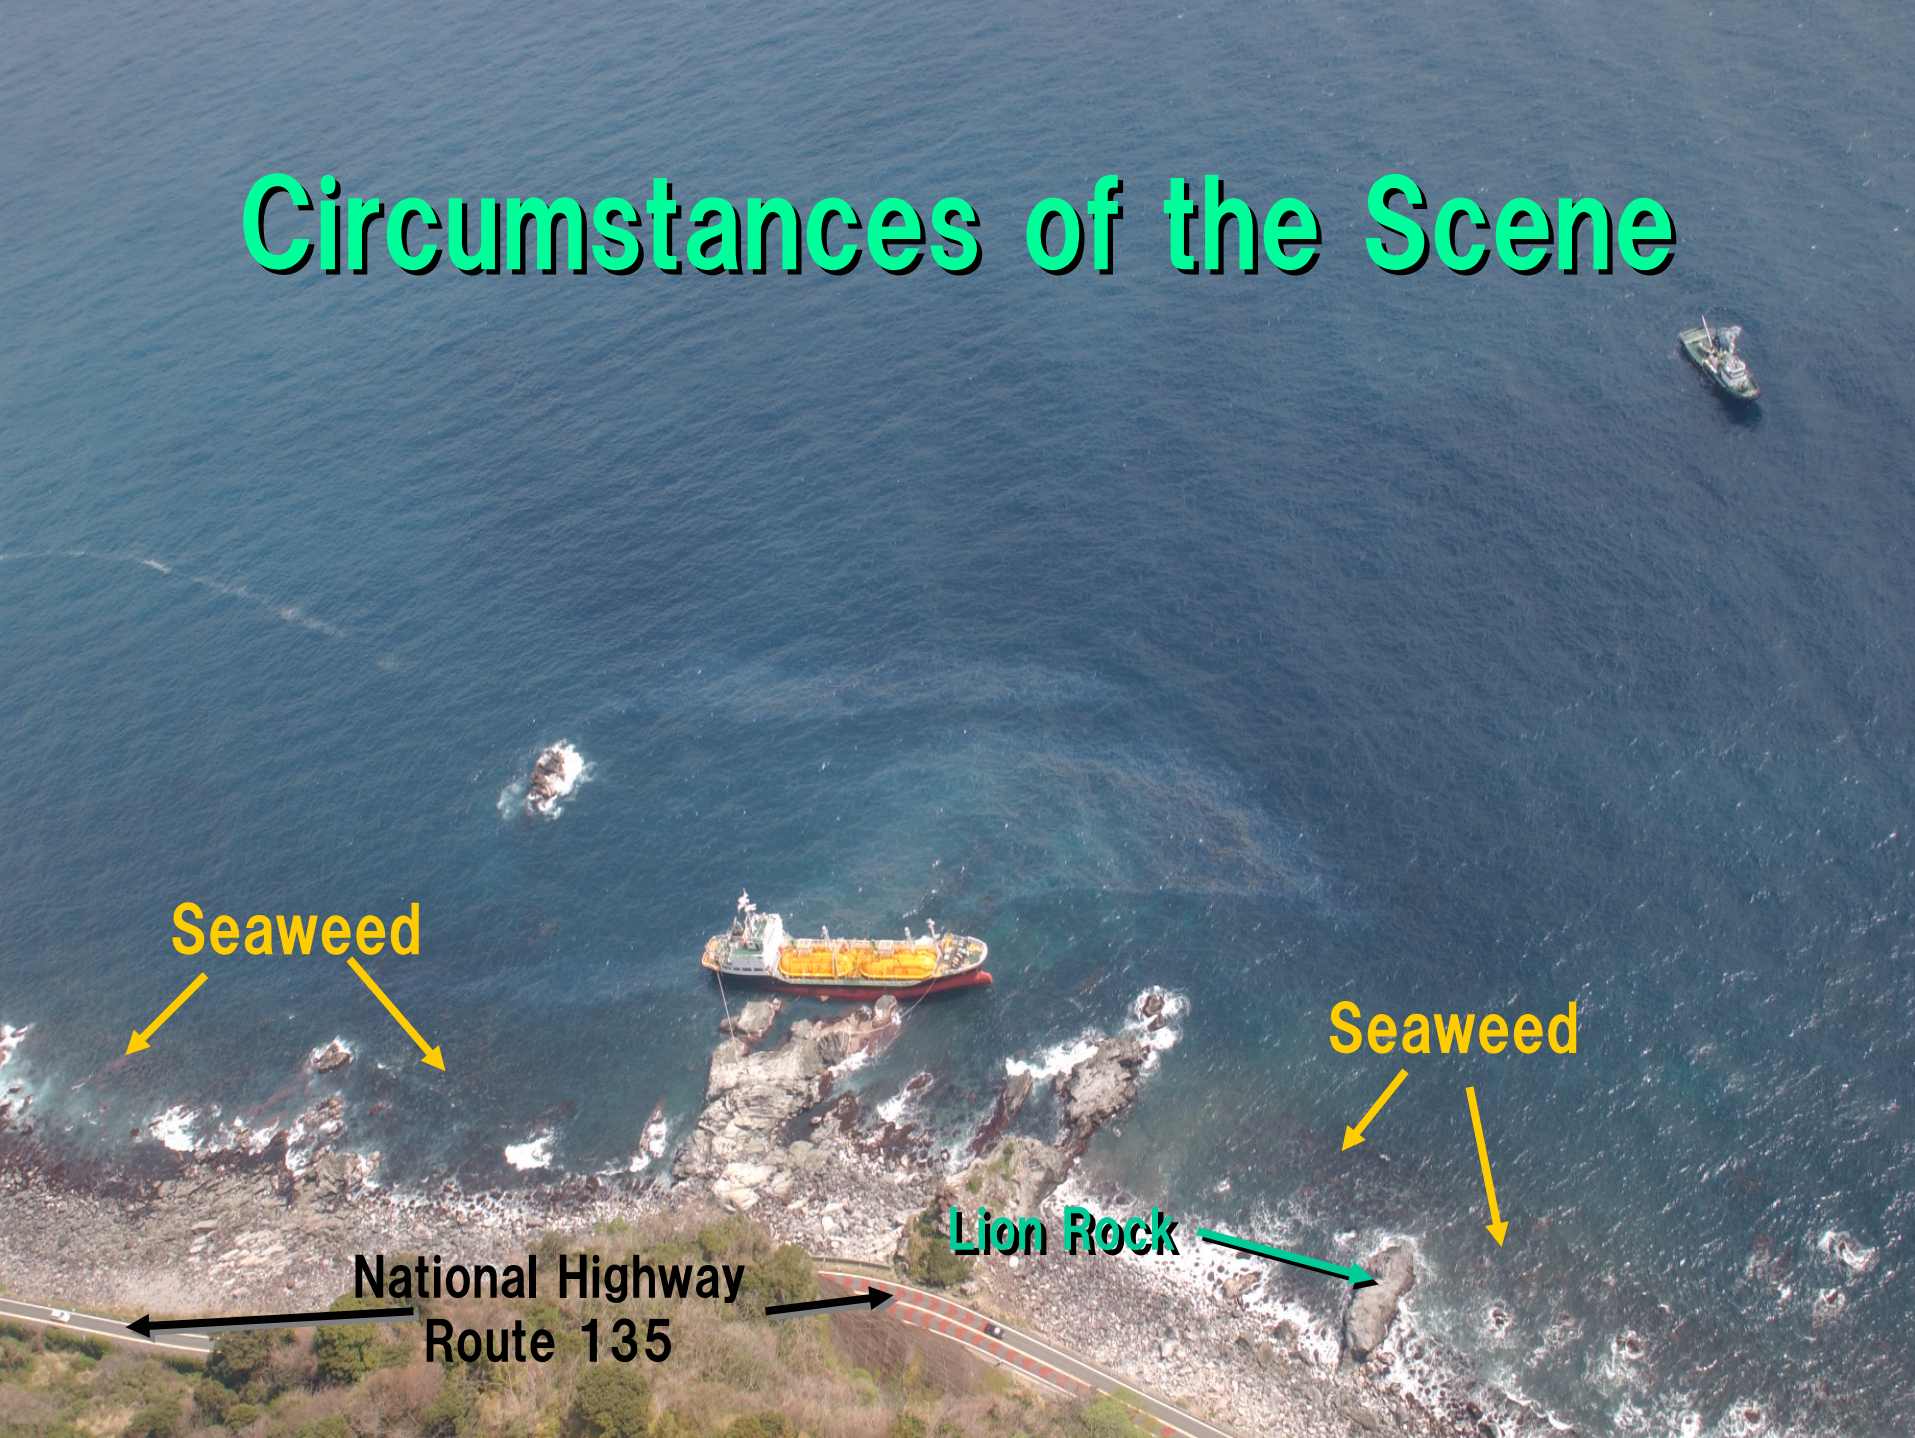
# Circumstances of the Scene

- Water Depth : 0.5 - 5 meter
- Sea condition: 1 meter of wave height and swell at all times

- Flooded : the engine room and the water ballast tank
- Unavailability : the engine, the LPG transportation pump, etc
